Issue 4/2012

Canadian Aviation Service Difficulty Reports

TP 6980E
(4/2012)

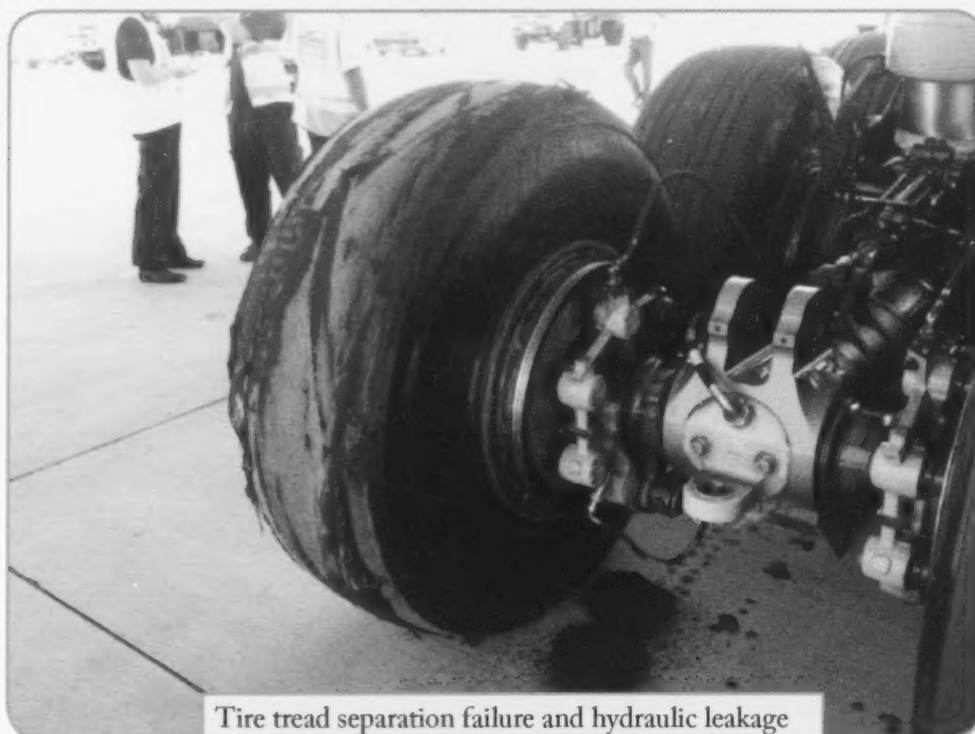
During cruise and approximately 4 hours prior to landing at the scheduled destination, the crew reported low hydraulic quantity in the center hydraulic system. An emergency was declared prior to landing and the aeroplane was met by emergency vehicles on arrival. The crew performed an uneventful landing, shut the engines down on the runway and was towed to the gate due to the inoperative steering system from the loss of the center hydraulics. Maintenance inspection at the gate confirmed extensive tire damage including the under-wing area and flap panel along with the associated tires brake line, which was the source of the hydraulic fluid loss.

Through further analysis and the retrieval of tire debris from the departing airport, it was concluded that the tire failed on take-off, damaging the aeroplane and causing the eventual loss of the hydraulic system. Concerns were raised of possible foreign object damage (FOD) being picked-up off the runway, causing the tire failure, but no direct evidence to support this was found.

The tire was replaced and sent to Bridgestone where a complete shop inspection and analysis was performed where no conclusive findings or indication of its failure or FOD was found. With this particular tire, an initial retread was applied where there were no clear indications of low adhesion between the tire retread components. The tire had also completed 139 landings prior to its failure and typically flaws with material or workmanship during the retreading process would result in a tread separation quickly after installation.

Tire tread separation failure and hydraulic leakage

The concluding corrective action defined by Bridgestone is the standard tire maintenance practice of the operator which includes checking for indications of damage from FOD or any signs of developing bulges or bubbles. Maintaining correct tire pressure inflation are also essential preventative measures to help guard against the possibility of tread separation, tire failure and possible extensive aircraft damage. ✖

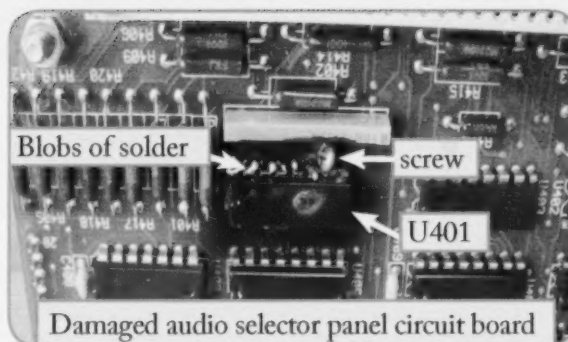
The aeroplane returned to the gate due to loud feedback on the captain's audio channel and a report of electrical smell. Maintenance confirmed that the captain's audio selector panel (ASP) failed, causing the electrical smell. The defect was resolved through the replacement of the ASP and tested as per Aircraft Maintenance Manual 23-50-00.

Feedback from the operator through the ASPs shop teardown report confirmed its failure due to foreign object damage (FOD) where a dislodged screw was found within the unit, causing a short.

It is suspected that while the aeroplane was in operation, a screw was inadvertently dropped into the ASP, causing the eventual failure of the unit.

Transport Canada Civil Aviation would like to advise all operators and maintainers of the dangers of FOD. ✖

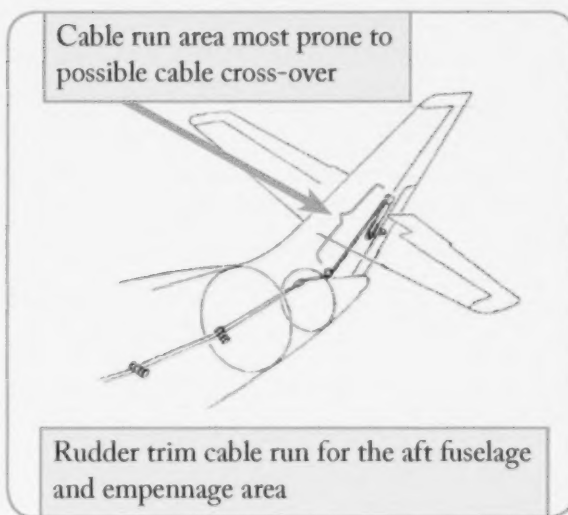
During a maintenance inspection of the rudder trim tab control system, it was noted that the rudder trim cables were crossed in the leading edge of the rudder above the lower leading edge panel.

The Aircraft Maintenance Engineer, through consultation with other operators, has confirmed several other similar occurrences where it has been stated that rudder cable cross-over in the vertical stab is a known problem and "it is easy to do".

Both cables were replaced due to minor kinks noted and installed correctly as per Aircraft Maintenance Manual (AMM) 27-23-11.

Transport Canada Civil Aviation is advising all BAE 3112 operators and maintainers of the possibility for the elevator trim cables to be twisted and to follow the AMM 27-23-11 procedures closely. ✖

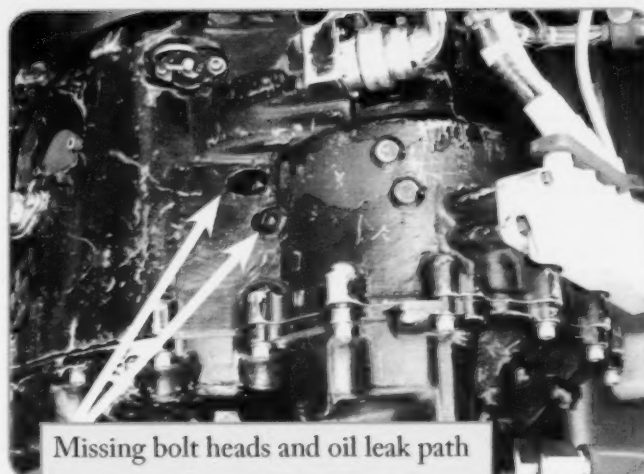
The flight crew disconnected the left Integrated Drive Generator (IDG) approximately 3 hours into the flight due to the drive light and Engine Indication and Crew Alerting System (EICAS) message illuminating. Maintenance discovered two adjustment bolt heads missing and oil in the cowl.

Oil is believed to have escaped under pressure past the broken bolt heads.

The operator has only seen this issue once before in 1999. The suspected issue is the stator and housing clearance wearing over time. As the clearance increases, the load being applied to the IDG makes the stator try to turn inside the unit due to the magnetic field and the rotation of the rotor (1200 rpm). The stator moves more and more as the wear on the bolt holes increase (elongation of the holes is evident on the housing).

The IDG was replaced and the aeroplane was made serviceable.

Transport Canada Civil Aviation would like to advise all aircraft maintainers of the possible inherent wear characteristics for this style of electrical generator. ✖

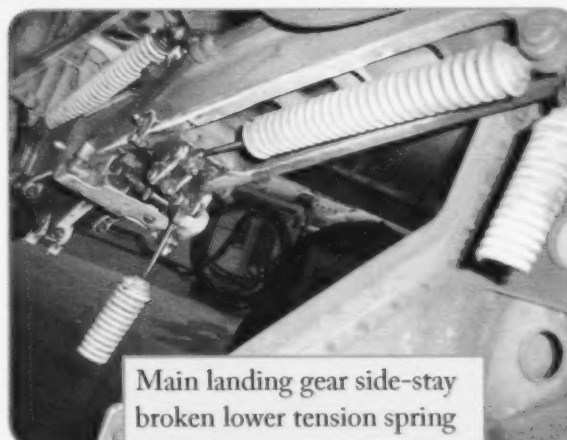
It was during a service check walk-around inspection when maintenance found a broken left-hand main landing gear side-stay lower tension spring.

The standard walk-around inspection for any aircraft is the most widely used inspection task in aviation. Often enough, it is also the last inspection task done before flight and because of this it is considered an essential task for the continued safe operation of the aircraft. ✖

The tension spring was replaced and the aeroplane was made serviceable.

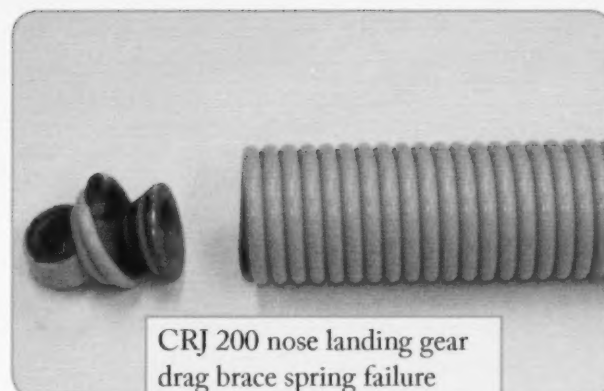
On a pre-flight first flight of the day walk-around check, it was noticed that on the nose landing gear, the right hand drag brace spring was broken and hanging.

The function of the drag brace gear spring is to assist the operation of the drag brace assembly towards its over-center, down-locked position.

The failure of a spring may lead to a possible inability to safely over-center the drag brace and down-lock the gear.

The discrepant spring was replaced and the aeroplane was made serviceable.

Transport Canada Civil Aviation would like to advise all owners, operators and maintainers to pay close attention to the condition of these springs. ✖

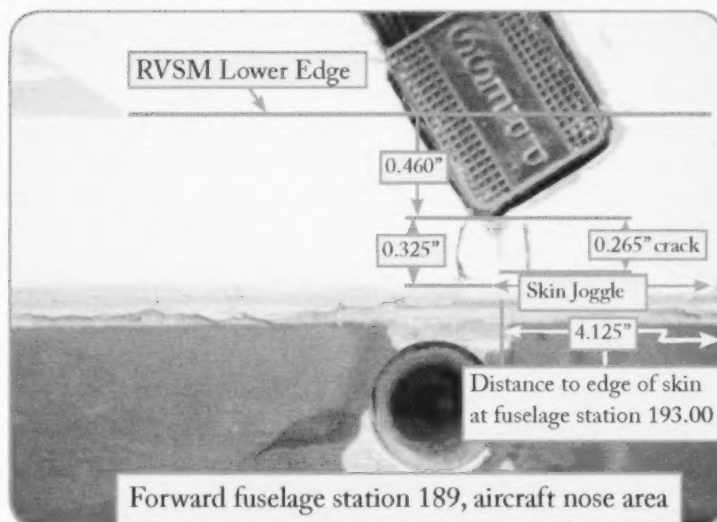
During a scheduled in-house task for a scratch and dent survey of the external fuselage, the Aircraft Maintenance Engineer noticed a crack emanating from the aft latch cut-out of the left hand electronics bay door at the nose of the aeroplane.

The crack was located at Fuselage Station 189, water-line 75.25 just below the Reduced Vertical Separation Minimum (RVSM) critical area. The damage was reported to Bombardier where the aeroplane was returned to service in accordance with temporary disposition Repair Engineering Order (REO) 601R-53-11-2189.

A similar occurrence has been found on another CRJ of the same operator where Bombardier engineering has been notified.

Transport Canada Civil Aviation is advising all CRJ operators and maintainers to be aware of this area for possible crack formations and the available Bombardier repair order. ✖

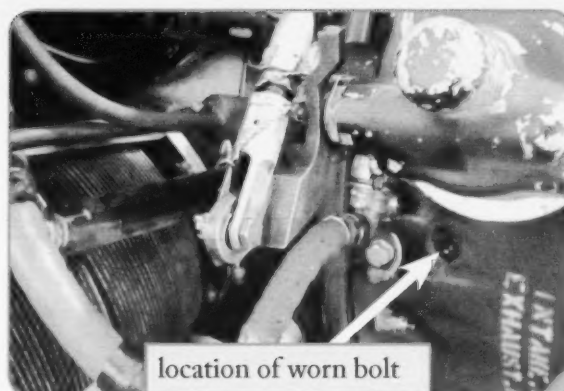
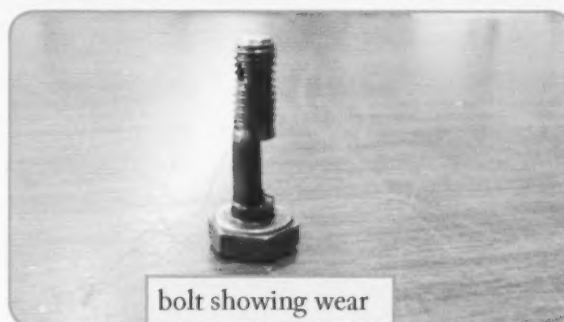
The bolt that attaches the left hand propeller governor cable fork end to the propeller governor lever was found severely worn part way through the shank of the bolt. This was discovered during a scheduled engine maintenance check. When the lever was wiggled to check for tightness and security, obvious play was noted. The rod end bearing in the lever was solid within the governor arm. The bolt was removed and found worn.

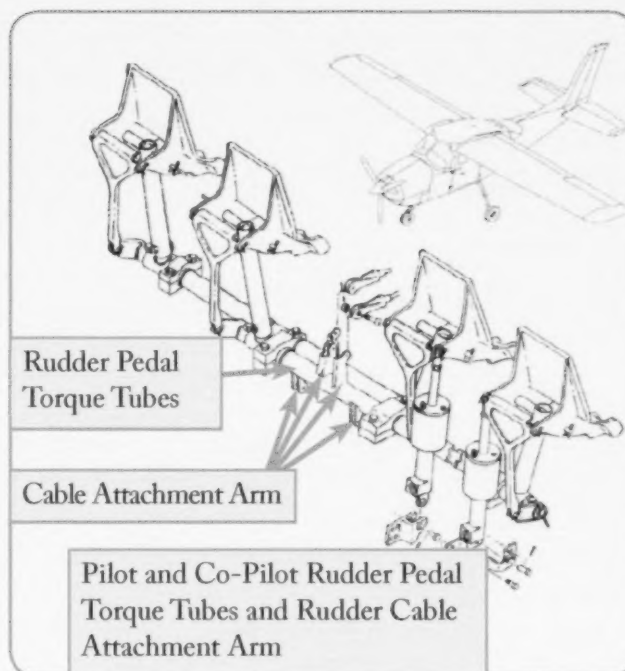
During inspection, the pilots left hand rudder pedal arm, part number (P/N) 0411307, was found loose and severely corroded at the torque tube, P/N 1260465-5. Internal inspection of the mounting arm and stub end of the torque tube revealed severe corrosion in various locations. Two of the four rudder pedal mounting arms showed significant internal corrosion.

Additionally, the interiors of torque tubes, P/N 1260456-5 & 12600456-6, were also found significantly corroded when disassembled. The inboard rudder torque tube bearing blocks were found cracked on both sides.

The Federal Aviation Authority is aware of the corrosion problems and has advised Transport Canada Civil Aviation that Cessna will soon issue Supplemental Inspection Number (SID) 27-20-01 to verify the integrity of the rudder pedal torque tube assembly. (effectivity 21059062 thru 21059199). Areas of particular concern are rudder torque tubes, cable attachment arms and weld area degradation due to corrosion or fatigue. ✖

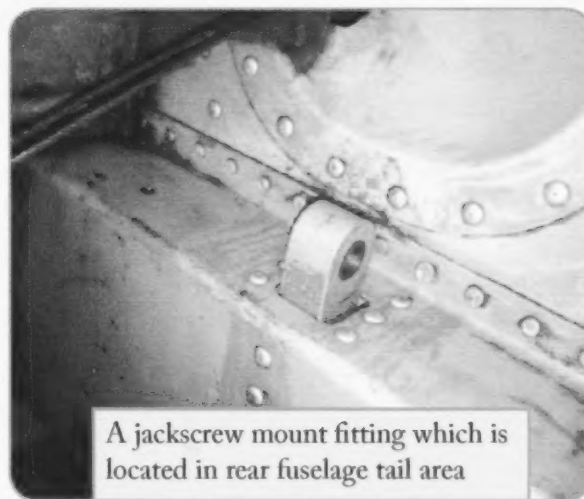
During a repetitive inspection of the horizontal stabilizer trim jackscrew; it was found that the bottom jackscrew mount was loose and was working into its fuselage-mounting retaining bracket.

Following the removal and disassembly of the fuselage-mounting bracket, it was discovered that three mounting rivets and their associated holes were worn (elongated) causing the bracket to become excessively loose.

This is an area that needs attention during inspections. Should the jackscrew mounting bracket become jeopardized; it could cause an undesirable flutter condition affecting the stabilizer trim flight control system. ✖

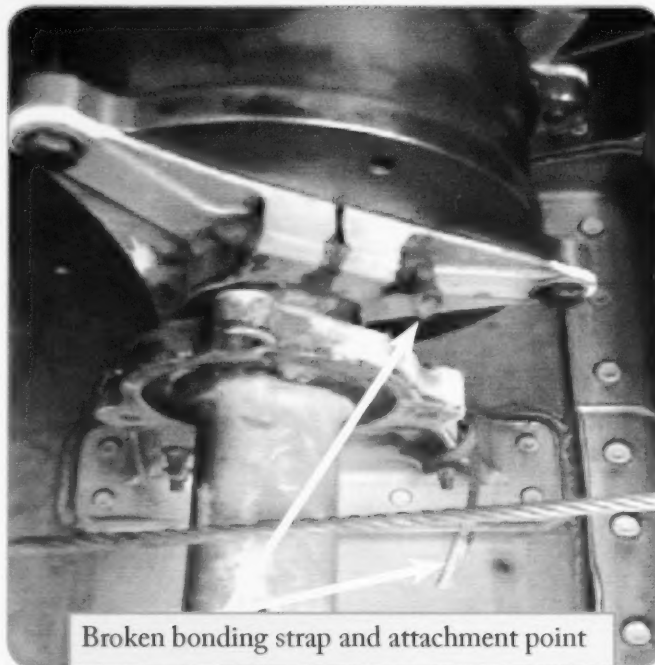
Further maintenance investigations revealed a broken bonding strap on the right-hand aileron torque tube located in the right main landing gear wheel-well. These bonding straps have been known to cause the stiff aileron fault and from examination of the area, evidence of the strap having interfered with the bearing support was noted.

Broken bonding strap and attachment point

Embraer have issued Service Newsletter (SNL) 190-27-0009R01, defining this possible scenario with recommendations for the proper installation of the bonding strap to prevent interference. ✖

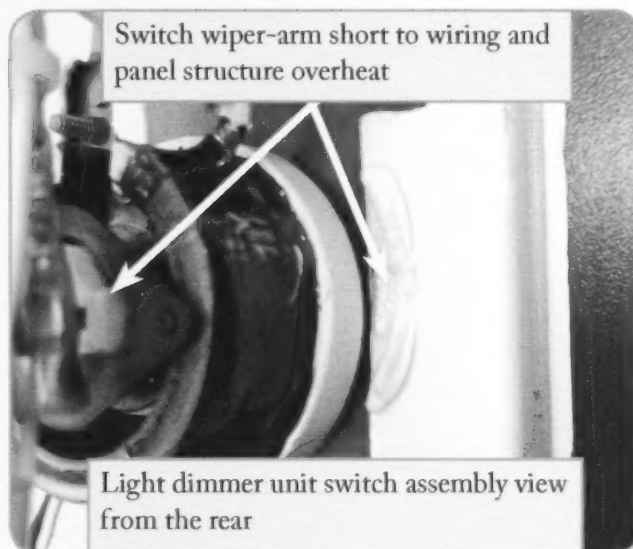
The co-pilots instrument backlighting system was snagged as inoperative. Maintenance found the co-pilots light dimmer unit switch had failed due to its potentiometer wiper-arm coming into contact with the surrounding wiring behind the instrument panel causing the light dimmer to short out. This in turn caused the potentiometer to overheat, melting the panel and leaving burn marks on the surrounding wiring.

Switch wiper-arm short to wiring and panel structure overheat

The wiring was re-secured away from the potentiometer and the switch assembly was replaced.

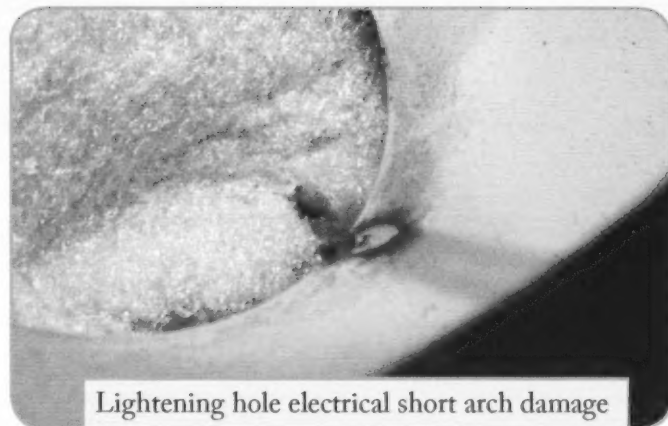
During a major inspection of the aeroplane, all cockpit windshields were removed for inspection of associated structure. Upon installation of new windshields, the airframe wire connections for the right-hand heated windshield were too short so were removed from the cockpit overhead run for replacement with new longer wires. Upon removal of the wire loom, one wire # H307/C12 was noted in having a significant burn mark. Further inspection showed a corresponding burn mark in a lightning hole where the wire passed through at frame 15.

The discrepant wire loom was installed 12 years previous as part of Service Bulletin (SB) 30-005, however a braided hose or grommet was not used at the lightning hole as a means of chafe protection defined in the SB. There were no previous reports of windshield heat defects recorded in the log book. The damaged lightning hole was repaired per Structural Repair Manual (SRM) procedures and the wire loom replaced.

Lightning hole electrical short arch damage

Correct wire harness support, insulation and protection from chaffing are essential standard practices for the continued operation of an aeroplane. With this case, not only was the defined task for a grommet installation missed during the incorporation of a SB by the Aircraft Maintenance Engineer (AME) responsible, the applicable standard practice was omitted also.

As AMEs, we are all responsible in knowing and following our Instructions for Continuing Airworthiness (ICAs), as with this scenario being the SB and Aircraft Maintenance Manual Standard Practice reference. ✖

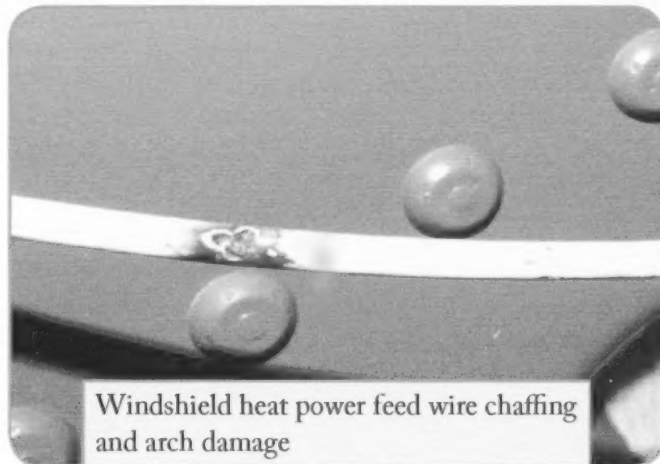
Windshield heat power feed wire chaffing and arch damage

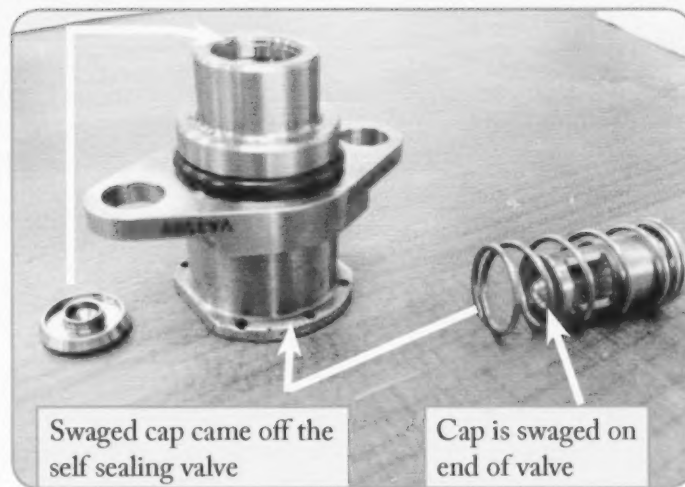
During master magnetic chip detector (MCD) inspection, on removal of the MCD probe, the self sealing valve broke off and fell down the oil tube. The oil tube was removed to recover the parts, the MCD housing was replaced (part number VA3509), the parts were sent to engineering and Rolls Royce was advised.

Caution is advised whenever disassembling aeroplane components. Thankfully in this case, the broken piece was easily recovered and did not damage another component. ✖

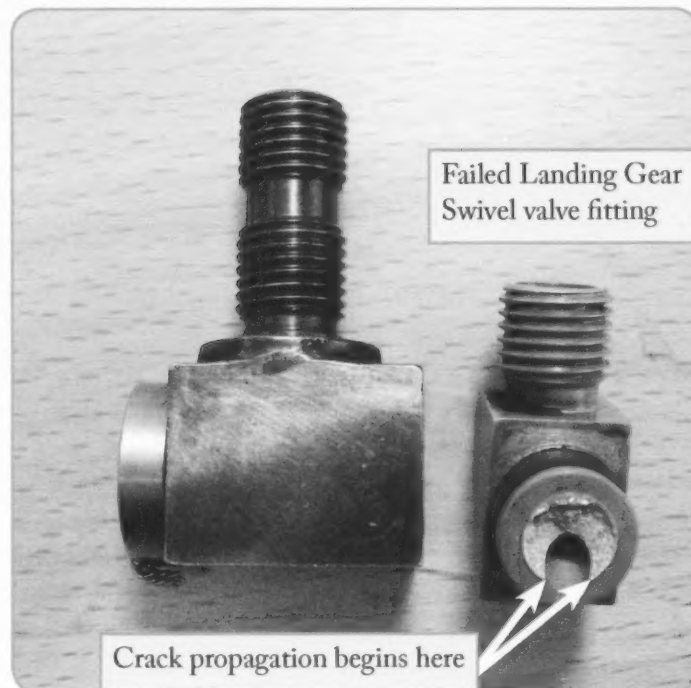
On climb-out during gear retraction the crew noticed a decrease in the hydraulic pressure while the pump was running with an eventual complete fluid loss. The aeroplane returned to the airport and the landing was uneventful. The cause of the problem was a failed landing gear (LDG) down-lock actuator hydraulic swivel valve. A fitting of the valve had split and allowed the loss of the hydraulic fluid.

Through the research of our Service Difficulty Report database via the Web-based Service Difficulty Reporting System (WSDRS), a high failure rate of these swivel valves was noted.

The swivel valve was replaced and the aeroplane was made serviceable.

Transport Canada Civil Aviation and SAAB engineering are working together to address this issue and a possible design change is pending for a change of swivel valve material through a Service Bulletin.

All operators and maintainers are asked in the meantime to pay close attention to these LDG swivel valves for hydraulic fluid leaks which could indicate a possible internal crack condition. ✖

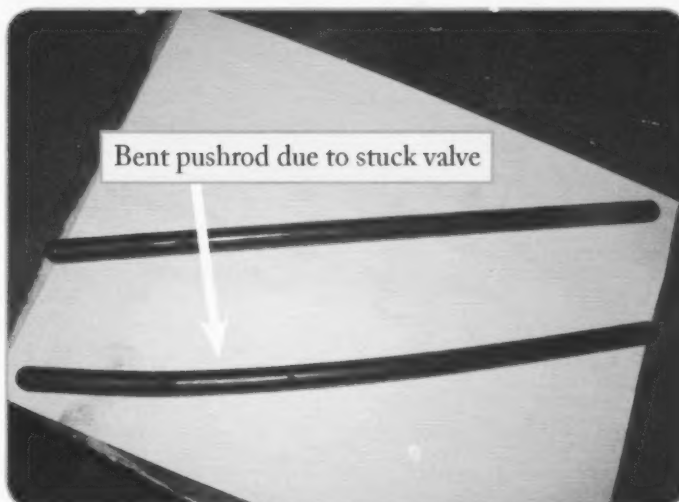
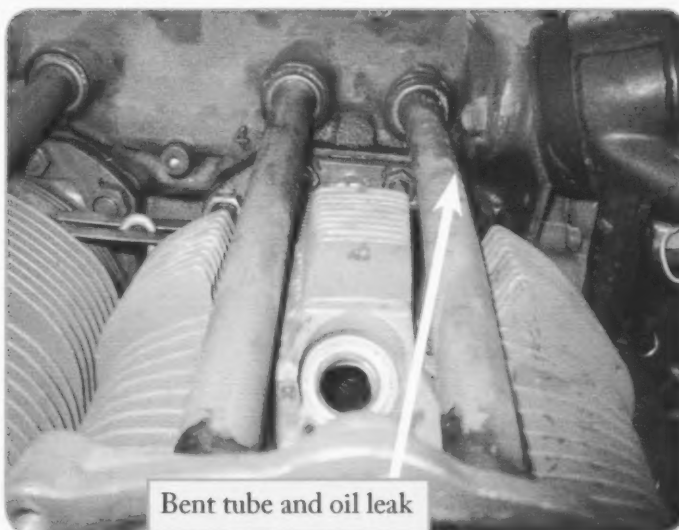
The aeroplane had to land because of a loss of engine power and high vibration. A stuck valve and bent push rod were found on the left-hand rear cylinder (engine was on condition). The customer decided to replace the engine with an overhauled unit. No damage to the aeroplane.

Operating a piston engine on condition can certainly offer significant cost savings to the owner. This does however come with certain risks. Extra maintenance can be performed to help mitigate those risks. As mentioned in a previous Feedback article, Avco Lycoming Service Bulletin (SB) 388 and Service Instruction (SI) 1425A provide great information regarding engine operation and valve maintenance. Both are available to the general public on Avco Lycoming's web site. (<http://www.lycoming.textron.com/>). ✱

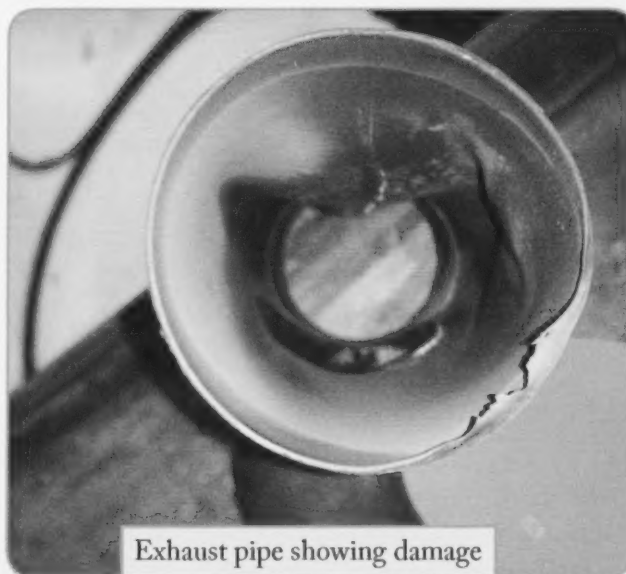
During the 100 hour inspection, cylinder #4 exhaust riser was found bulged at the collector. The bulge is consistent with the direction of cylinder #4 exhaust flow. Upon removal, the exhaust was noticed to be quite thin and appeared to have lost material. A gentle tap with a soft faced hammer easily collapsed the pipe. The engine has individual cylinder head temperature and exhaust gas temperature probes so overheating would be unlikely. Engine cylinder #4 was still serviceable, no other issues were found.

Exhaust pipe showing damage

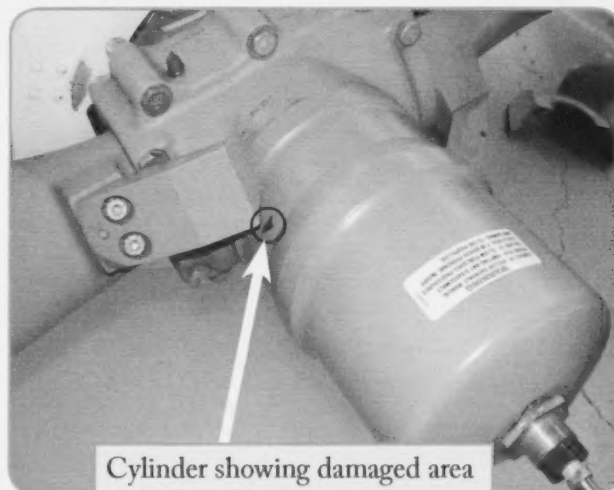
An investigation revealed improperly installed counter weights at some point in the propeller's history. A careful inspection is required after any maintenance task. ✂

Cylinder showing damaged area

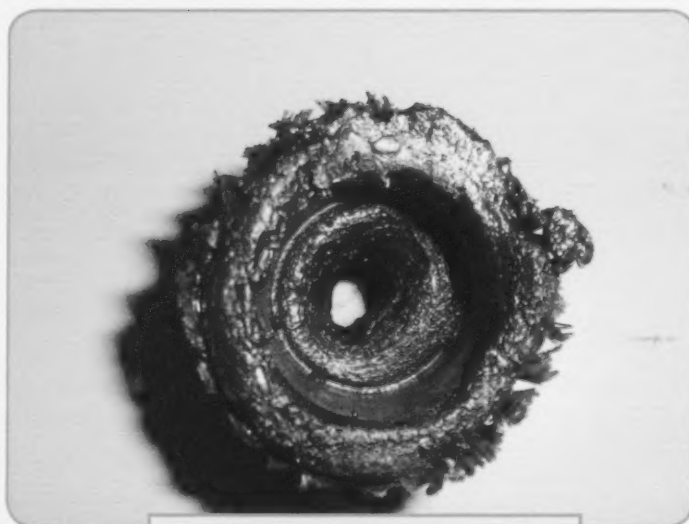
Left-hand engine was shut down after losing engine oil pressure in flight due to oil starvation. The aeroplane landed safely at the closest airport. A ground inspection revealed that the oil starvation was caused by a swollen engine breather line coupling that caused breather restriction. This restriction caused an internal engine pressure build up and oil escaping through the engine bearing labyrinth seal and accessory gearbox output shaft seal. A negligible oil leak was found on the left-hand engine cowling because a majority of the oil was internally burnt in the engine and could not be detected in-flight by the crew.

The swollen breather coupling, part number 159P10019-75, on the left-hand engine breather line rear section was repaired prior to 1997 and is not the original breather installation. The coupling was replaced. A ground run-up and a flight test revealed no more oil consumption on the left-hand engine.

Swollen coupling causing oil loss

Both engines breather lines were inspected for defective couplings before maintenance released the aeroplane.

The importance of proper inspection and attention to manufacturers' instruction (including their Service Bulletin publications) cannot be understated. In this instance it is likely that all instructions were followed, however the failure still occurred. It is also important that the manufacturer has access to the failed components so as to determine the root cause and develop fleet wide corrective action. ✱
